The Effects of Oxidation-Induced Failures on Thermal Barrier Coatings with Platinum  
Aluminide and NiCoCrAlY Bond Coats

N. M. Yanar, G. H. Meier and F. S. Pettit  
Materials Science and Engineering Department  
University of Pittsburgh  
Pittsburgh PA 15261

Prepared for  
Craig S. Hartley  
Air Force Office of Scientific Research  
801 North Randolph Street  
Arlington VA 22203-1977

December 1, 2001

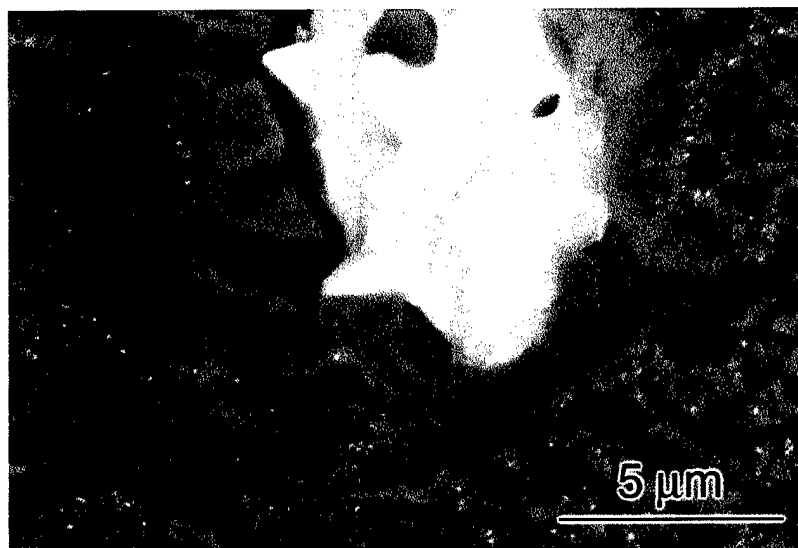
Figure 11. After cyclic oxidation of the platinum-aluminide coatings, refractory metal rich phases (tantalum and tungsten) were evident at the oxide-coating interface, (a) and (b). Such phases were also observed at grain boundaries in the coating, (c).

Before discussing the results obtained with the state-of-the-art TBC systems the oxidation characteristics of the bond coats without TBCs will be described. Both of the NiCoCrAlY bond coats and the platinum aluminide bond coats were cyclically oxidized at 1100° and 1200°C in the same furnace that was used to test the TBC specimens. The surface of the platinum aluminide bond coat became severely deformed during oxidation, Figure 9a, and voids developed in the bond coat just beneath the TGO. When the TGO above the void cracked, oxide was evident on the surface of the void, Figure 9b. The oxide scale did not spall excessively from the platinum aluminide bond coat but cracks were evident, Figure 10, in the alumina scale after cyclic oxidation. In cases where the alumina did spall it was not unusual to observe a refractory metal rich phase at the coating-TGO interface, Figure 11. Such phases were also observed at grain boundaries in the bond coat Figure 11c.

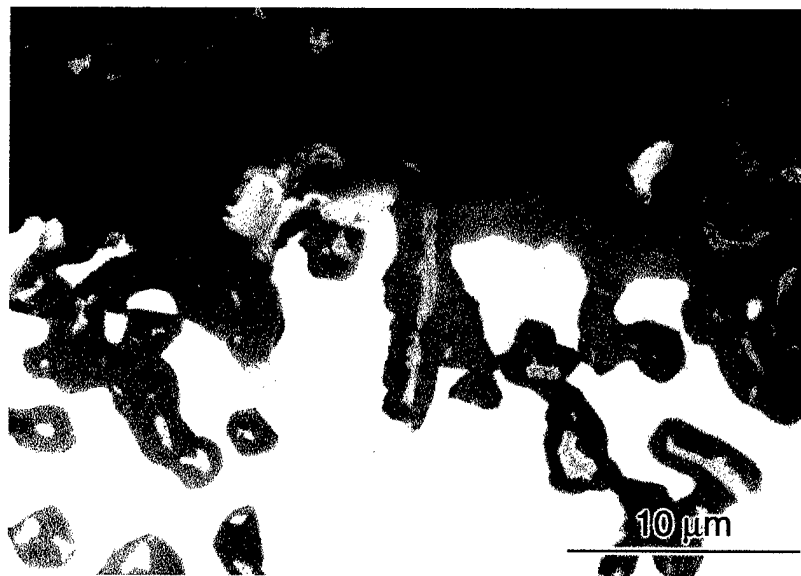
Figure 12. Scanning micrographs of NiCoCrAlY A showing cross sections of this coating after 209, (a) and (b), and 955, (c) and (d), cycles of exposure at 1100°C. Oxide protrusions extended into the coating at locations where yttrium rich oxides had been formed, (d).

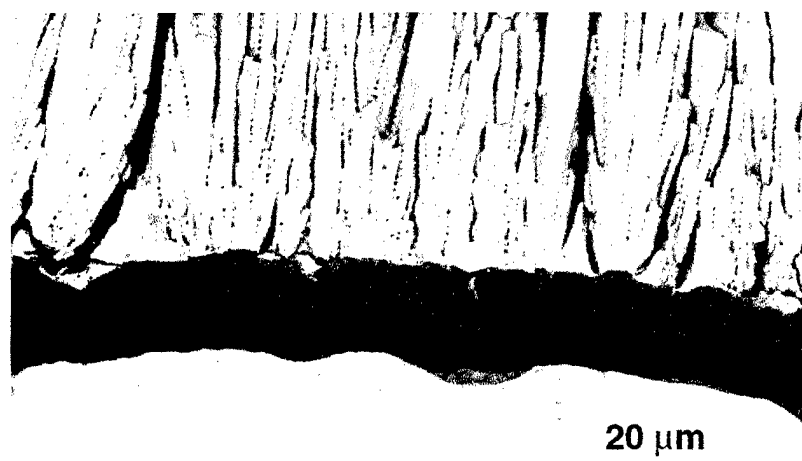
Figure 16. Scanning electron micrographs from the TBC system with platinum aluminide bond coat prior to failure (after 758 cycles of exposure at 1100 °C ) The detachment was observed to be in the TBC, TGO or along the TGO/TBC interface when numerous ratchets were present, (a), whereas it was along the TGO/bond coat interface when ratcheting was less pronounced, (b).

A substantial difference between the failure times for the platinum aluminide bond coats A, B and C was not apparent, Table 3. Furthermore, the failure characteristics were also similar. The TBC failures on the platinum aluminide bond coats occurred in the TBC near the TGO, Figure 14, and at times along the TGO-bond coat interface. When failure was in the TBC near the TGO, ratcheting<sup>(11)</sup> had occurred during cyclic oxidation, Figure 14. This ratcheting caused pieces of the TBC to become detached as shown in Figure 15. In those areas where ratcheting was not excessive, the failure proceeded along the TGO-bond coat interface, Figure 16.

The failures in the case of the TBCs on the platinum aluminide bond coats were essentially the same as those for the state-of-the-art platinum aluminide TBCs. Ratcheting of the TBC and TGO was evident, Figures 14, 15 and 16. The specimens that were given the light grit blast and the media finish had failure times of 1780 and 2280 cycles, respectively, which are significantly larger than failure times for the state-of-the-art TBCs. In Figure 27, cross sections of the as-processed TBCs with the light grit blast and the media finish are presented. The TGOs on these specimens are more smooth compared to the TGO on heavy grit blasted specimens, Figure 6a. The exposed specimens with the light grit blast and media finish surface conditions that failed have not been examined in detail as yet. Based upon the results available it appears that TBCs on platinum aluminide bond coats fail when the strain energy in the TGO exceeds the fracture toughness of the TGO-bond coat interface. Ratcheting<sup>(11)</sup> leads to premature TBC failures and smooth bond coat surfaces, Figure 27, result in longer TBC lives because ratcheting is less severe. Void formation was also evident in bond coats after TBC spallation, Figure 28. These voids developed at grain boundaries in the bond coat, Figure 28. At present the role of voids in the bond coat on TBC failures is not understood and more work is required to attempt to understand void development in bond coats.
